## **MINISTRY OF INFRASTRUCTURES AND TRANSPORTS**

### **Marine Casualties Investigative Body**

**COSTA CONCORDIA**

**Marine casualty on January 13, 2012**

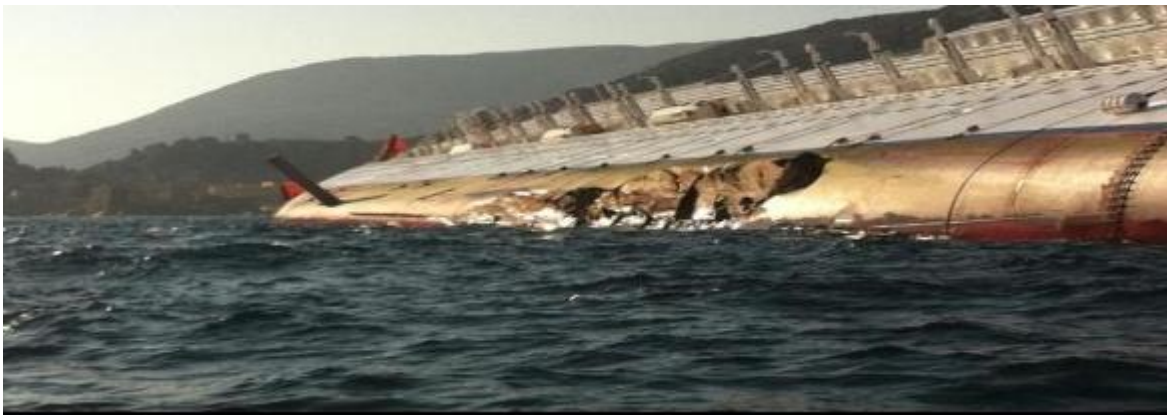
The hole on the left side upon impact, it is continuous for about 60 meters (about frames 52 to 124) located too far above the deck of the Double Bottom (so well over two meters from keel line). This was crucial in terms of severity of the accident, because rather than be hit the bottom of the ship, if the more defence due to the double hull, was vice versa affected area clear that, over the plate rail, relies directly its operating compartments (the heart). In particular, the testimonies of the 3rd Engineer Officer and 2nd Engineer Officer, as well as the 2nd Chief Engineer) - combined with audio recordings of communications between the VDR machine and Bridge - have established that in a few minutes (about 3 mins for the EMP and 7 for Diesel Generators Room. aft) the ship has lost Watertight Compartments (WC) nr. 5 and 6 (PEM and then Local DD.GG. aft), while the adjacent WC nr. 4 and 7 (respectively Compressors Galley Room and DG Room), were initially partially flooded, becoming initially dangerous free liquid water surfaces, and then completely filled after about 40 minutes from the contact.

The water appears to have also affected the adjacent WC nr. 3 and 8 (respectively Local Stores and Local Evaporators), which consists of more than free liquid surfaces, hazardous for the purposes of further reduction of the dynamic stability.

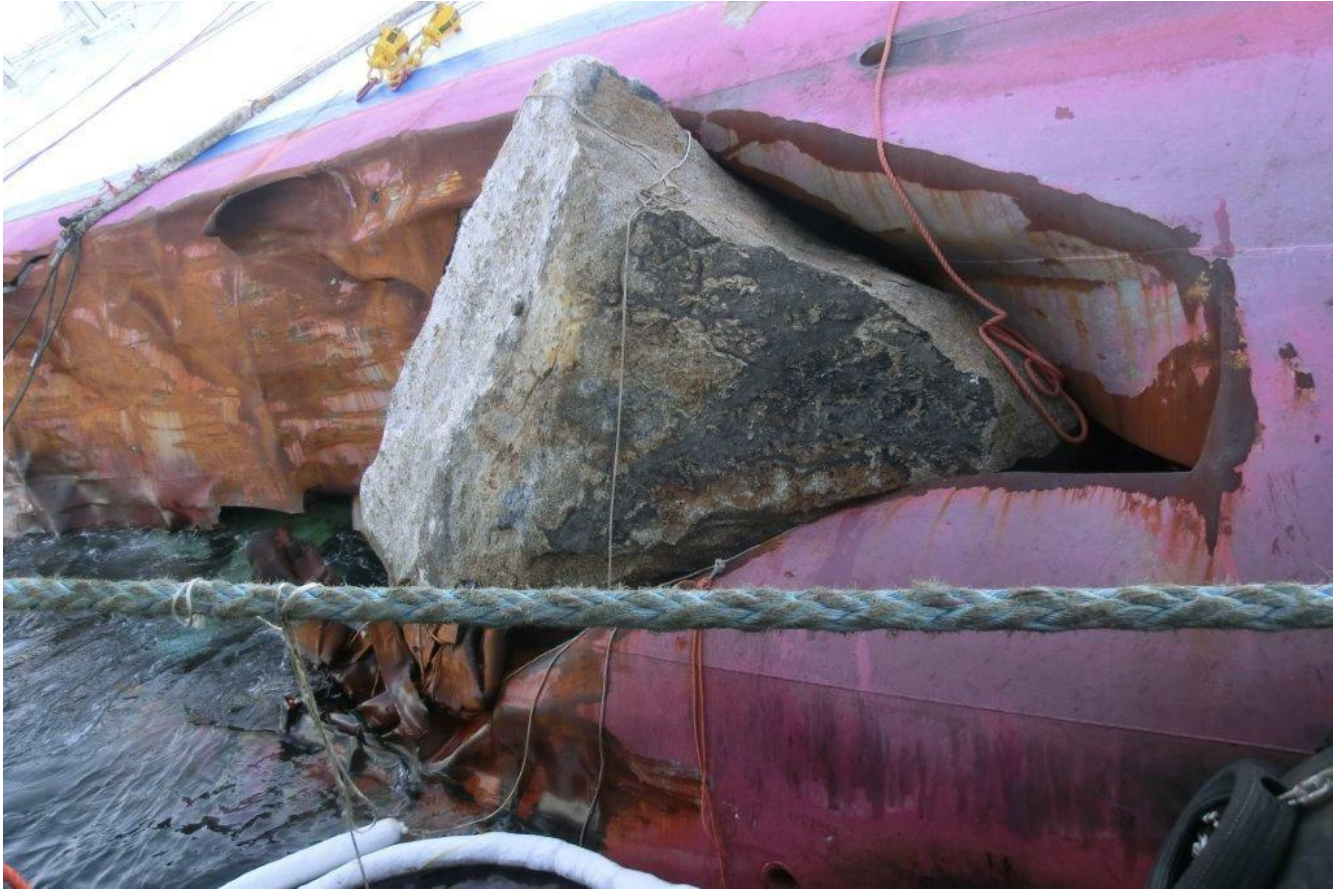
*Detached rock in damaged area*

An assumed density of 2.7 tonnes/m<sup>3</sup> has been used to estimate the buoyancy of the rock to allow the submerged weight of the rock to be applied in the moment calculation. It has been estimated that the transverse centre of gravity of the rock is at 10.7m from the centre line of the vessel. The calculated moment is applied in the simulation at time 213 seconds which is at the end of the first grounding event.

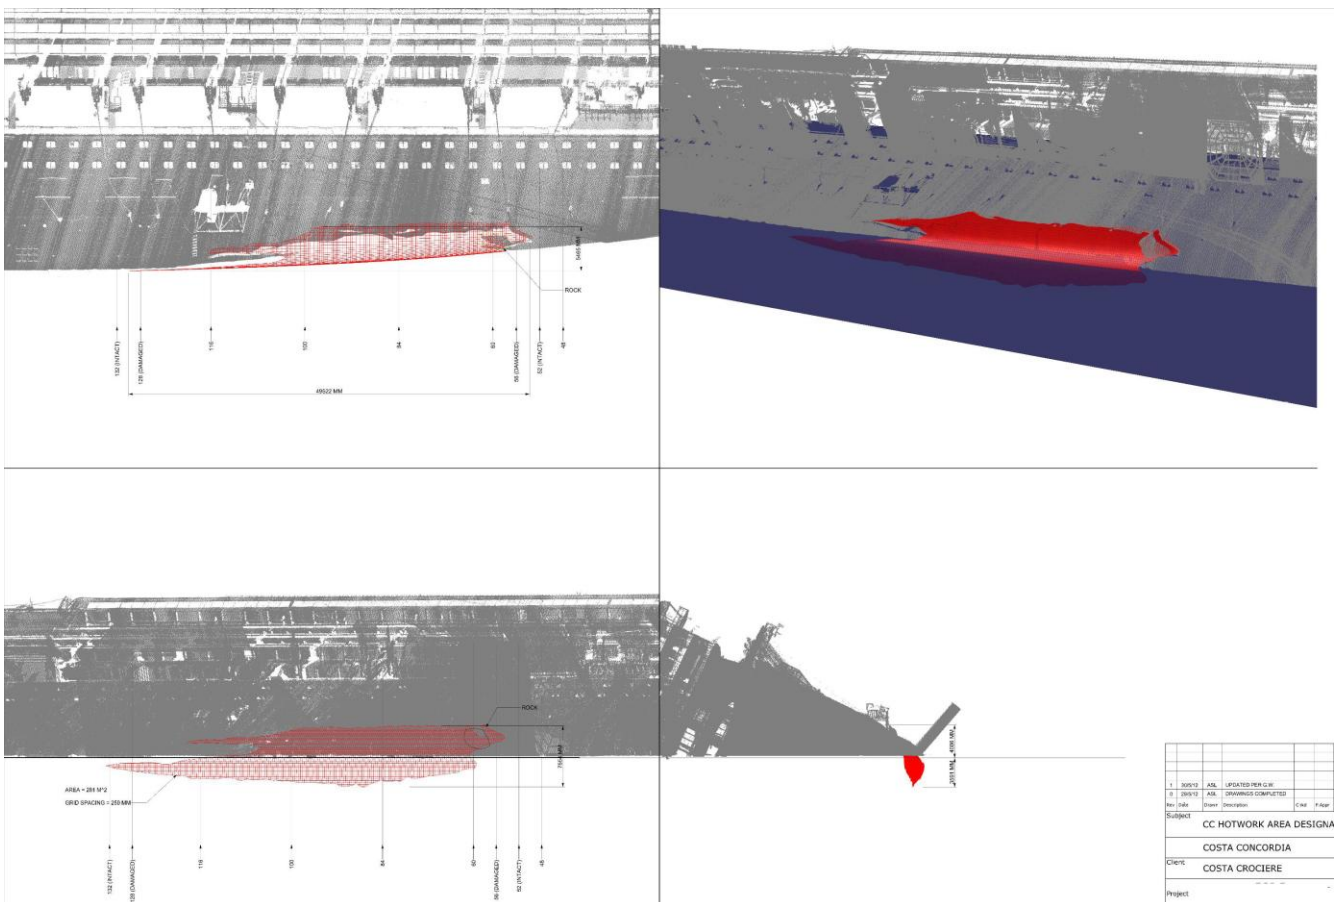
*Survey data from salvors*

According to the VDR data it results that the impact of the ship against the rocks of Le Scole occurred at 21.45.07 hours, immediately after the Master's order "hard to Port".

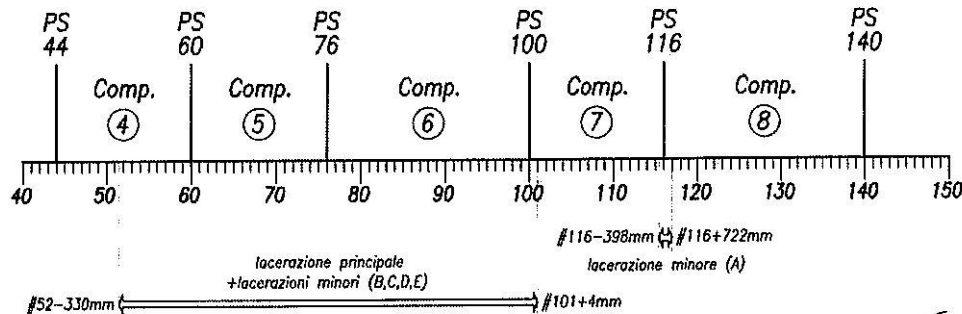
Figura 33

This damage is the cause of the flooding occurred to four contiguous compartments whose damage extension is considerably exceeding the one provided by the relevant regulations regarding the subdivision and stability checks in flooding (two flooded contiguous compartments) that is 10.710 m (ref. FINCANTIERI Booklet APN no. 320024 "INTACT AND DAMAGE STABILITY" approved by CDS no. 3211 dd. 10th March, 2005).

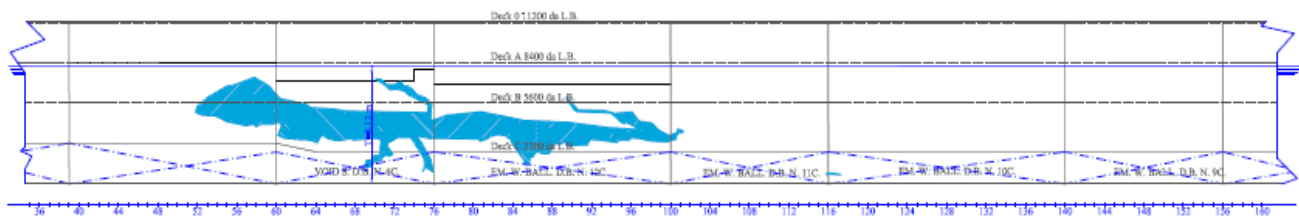
Proiezione sul piano longitudinale della falla principale e di quella minore a cavallo dell'ossatura 116

Where it is represented the longitudinal section involved by the damage upon which the shell plating breaches have been overlapped, according to their accurate assessment.

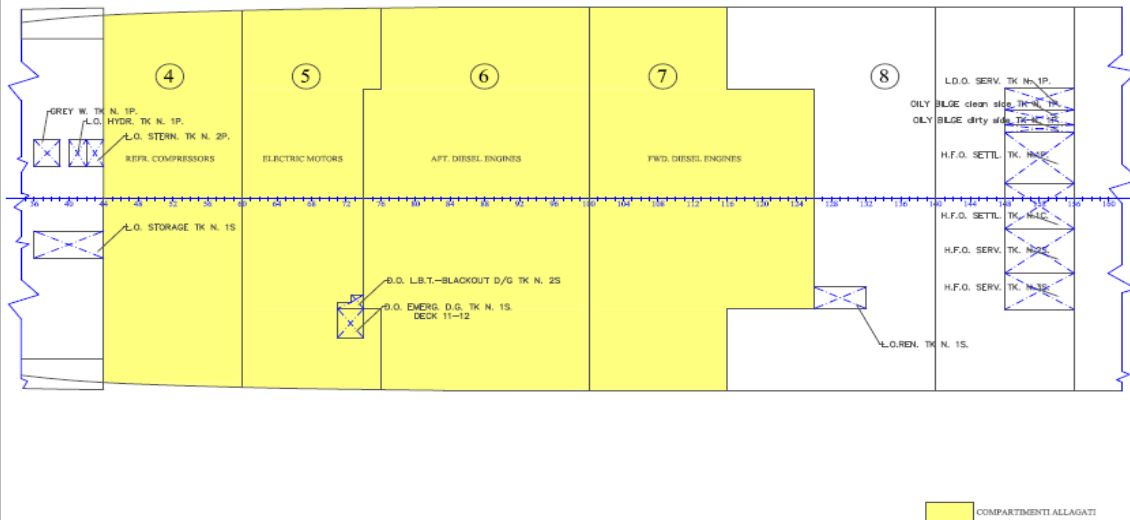
## Deck C

### Compartimenti allagati al Ponte C

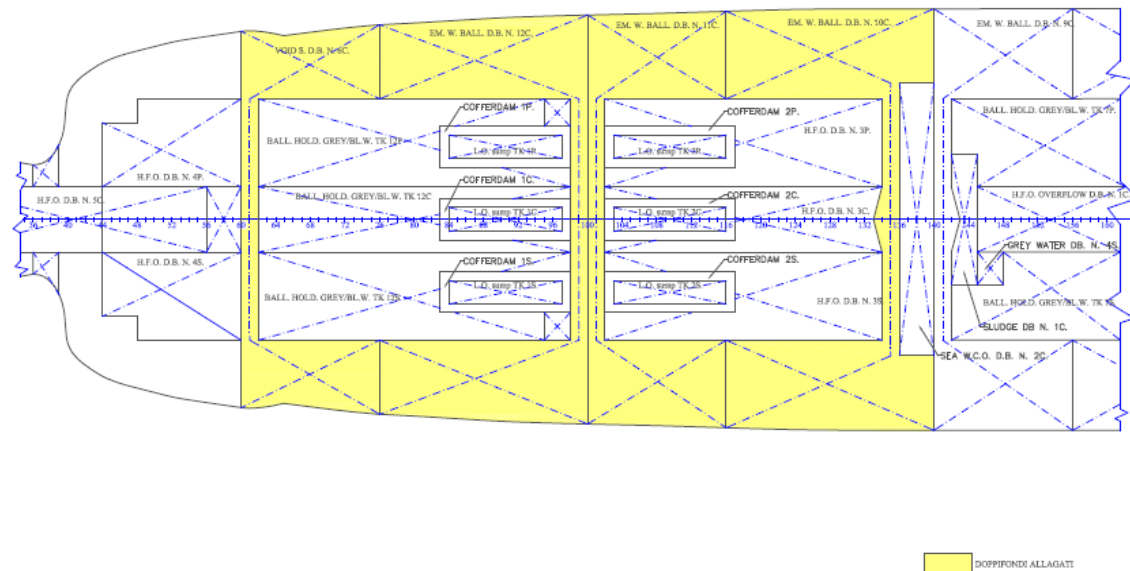
## Double bottom

### Doppifondi allagati

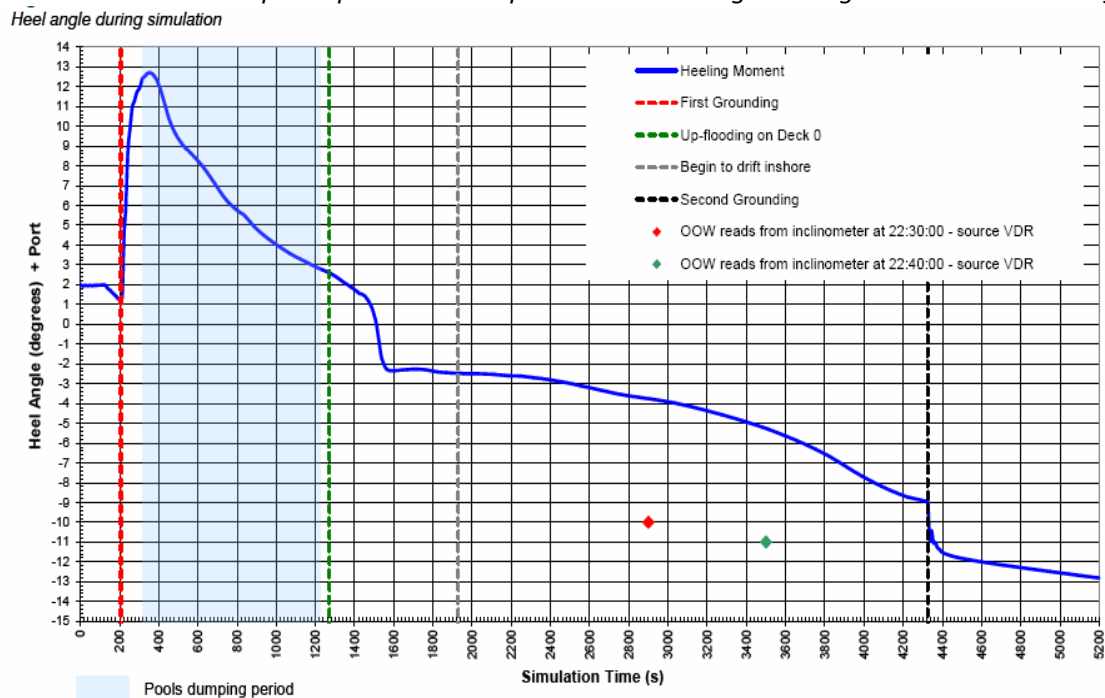
Following this combined moment and the flooding sequence described in Chapter 6.1 in the main 10 points we obtain the ship's response with respect to the heel angle through time as shown in Figure E:

We may evince that the two data points relating to the VDR information on actual heel angles at 22.30 and 22.40 hours read on the ship's inclinometer reveal that the simulation underestimates the heel angle to the stbd side by about 6°.

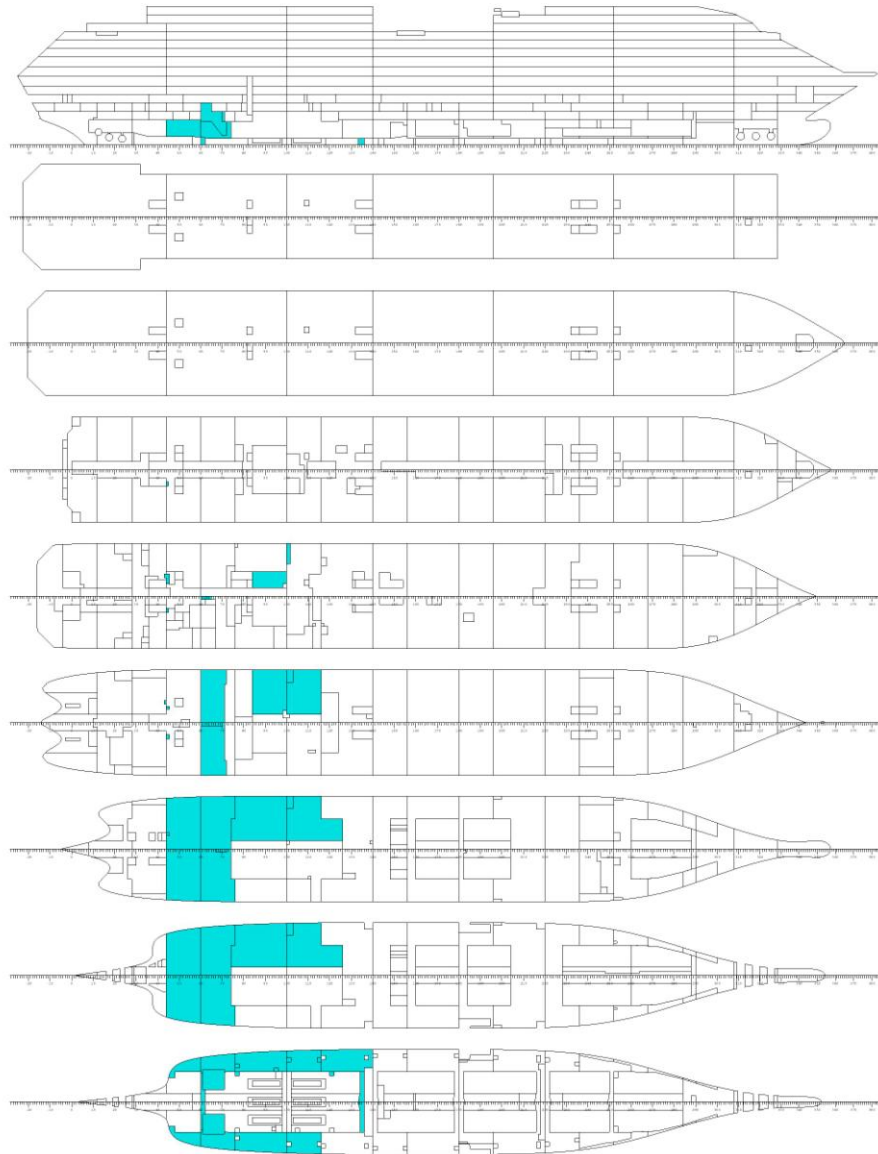
FLOODING EXTENT FOR KP1

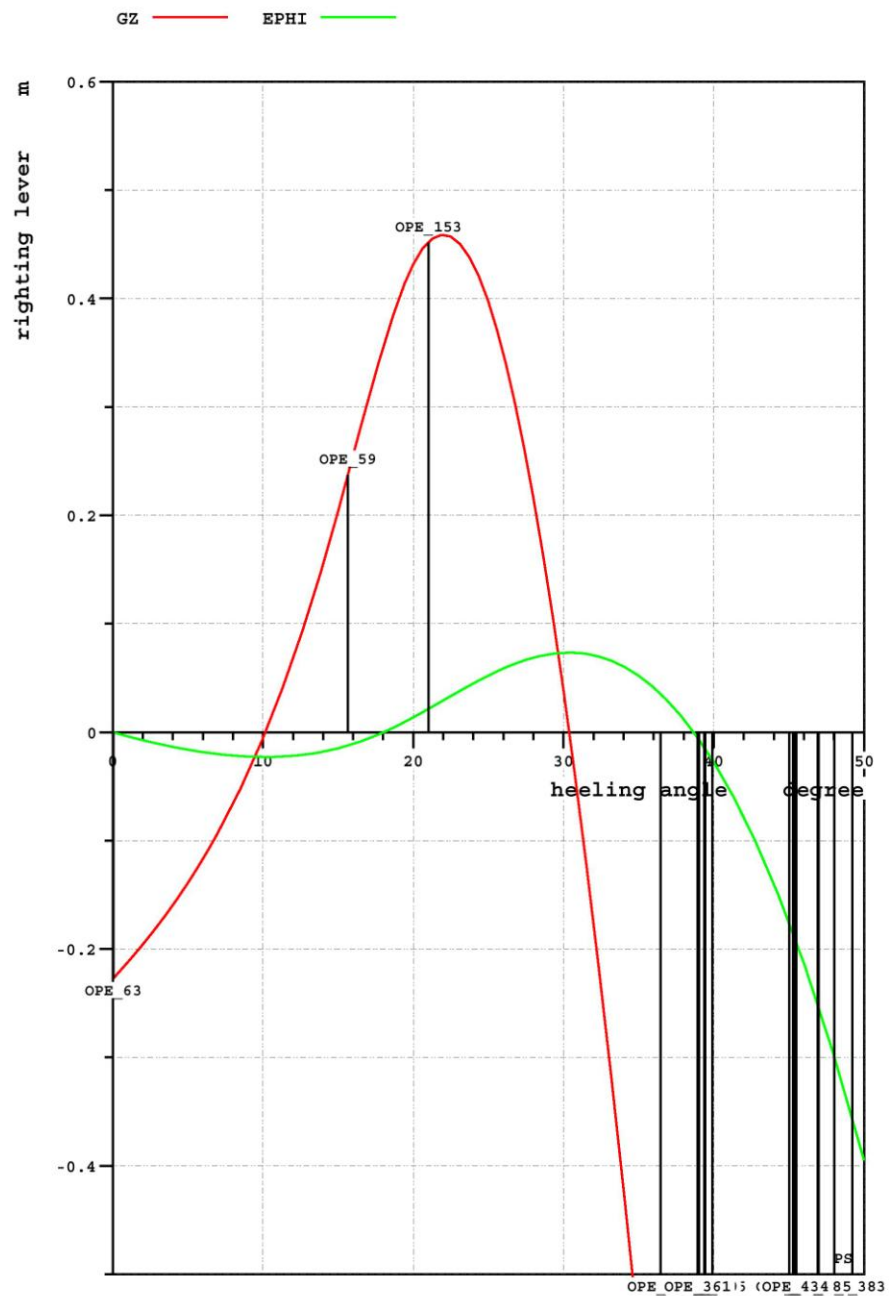
GZ CURVE ASSUMING NO PROGRESSIVE FLOODING FOR KP1

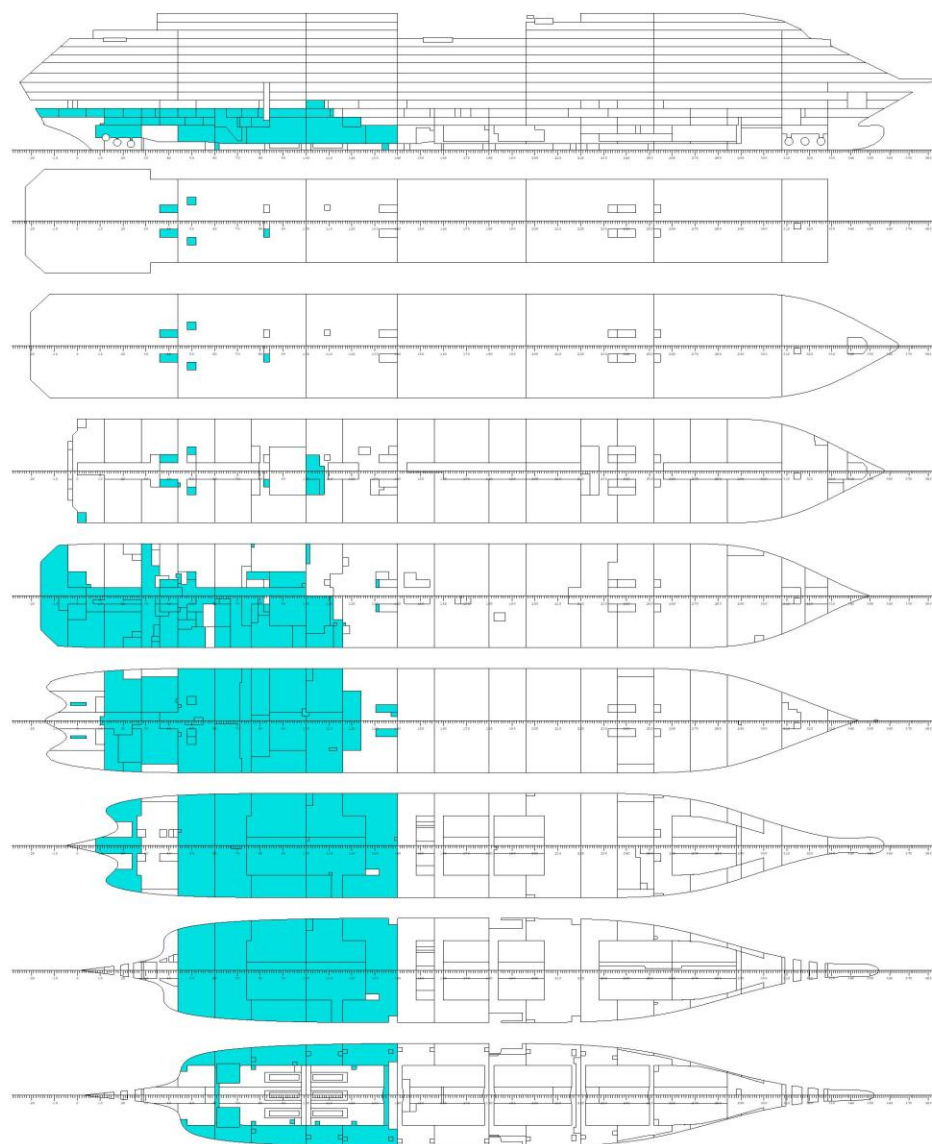
FLOODING EXTENT FOR KP10N  
NOTE: INDICATION OF SPACES CONTAINING FLOOD WATER NOT AMOUNTS

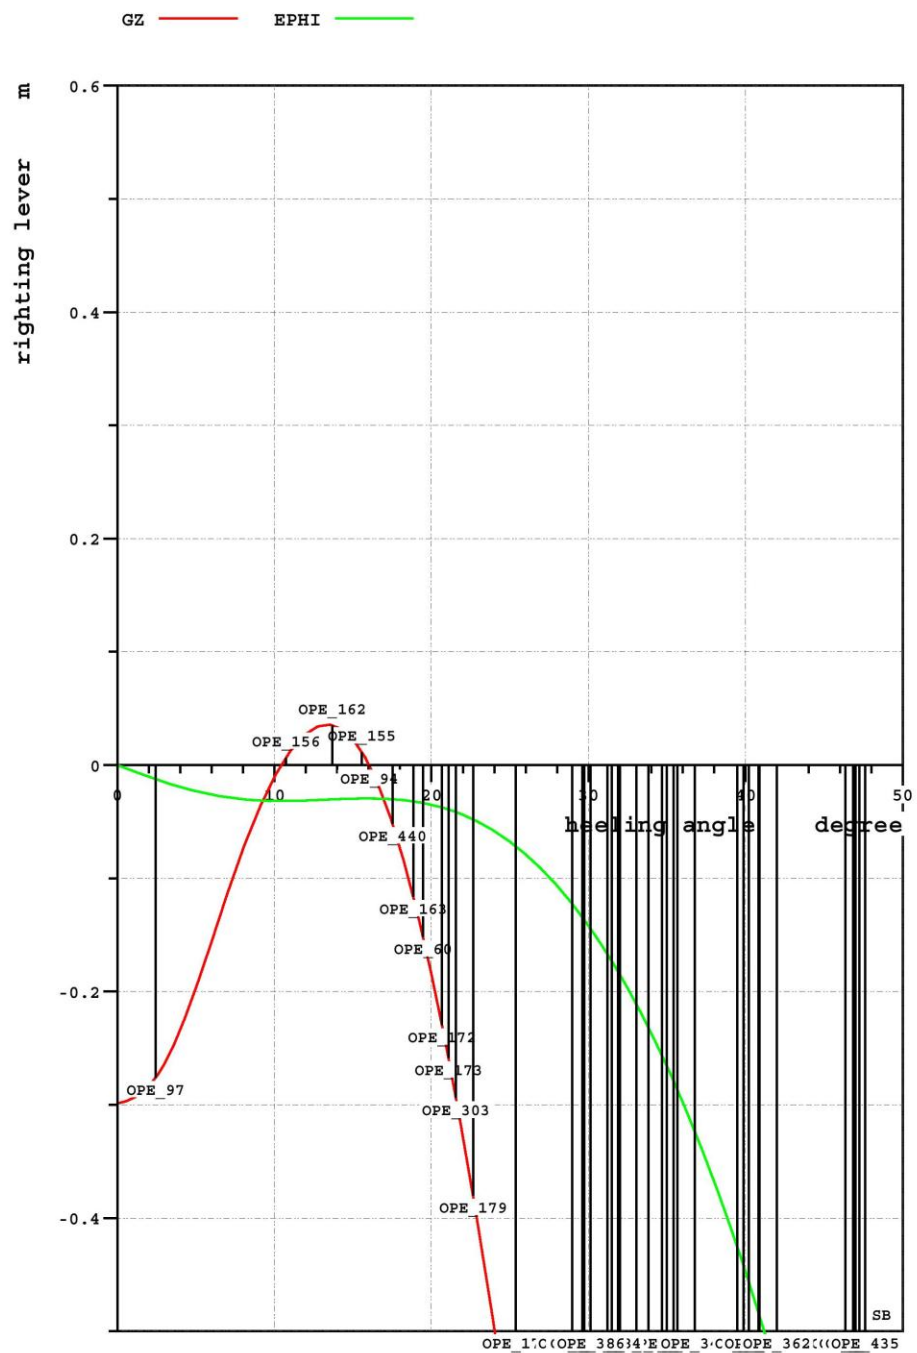
GZ CURVE ASSUMING NO PROGRESSIVE FLOODING FOR KP10N

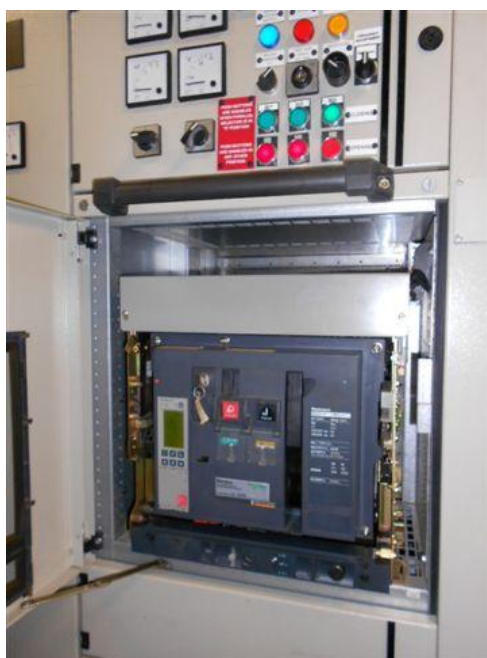
As per above the concurrency of a short circuit in the lines powered by the ES could be the most reasonable cause of the switch 901 improper functioning.

*Switch nr. 901 (picture taken from Costa Favolosa)*
