## **MINISTRY OF INFRASTRUCTURES AND TRANSPORTS**

### **Marine Casualties Investigative Body**

**COSTA CONCORDIA**

**Marine casualty on January 13, 2012**

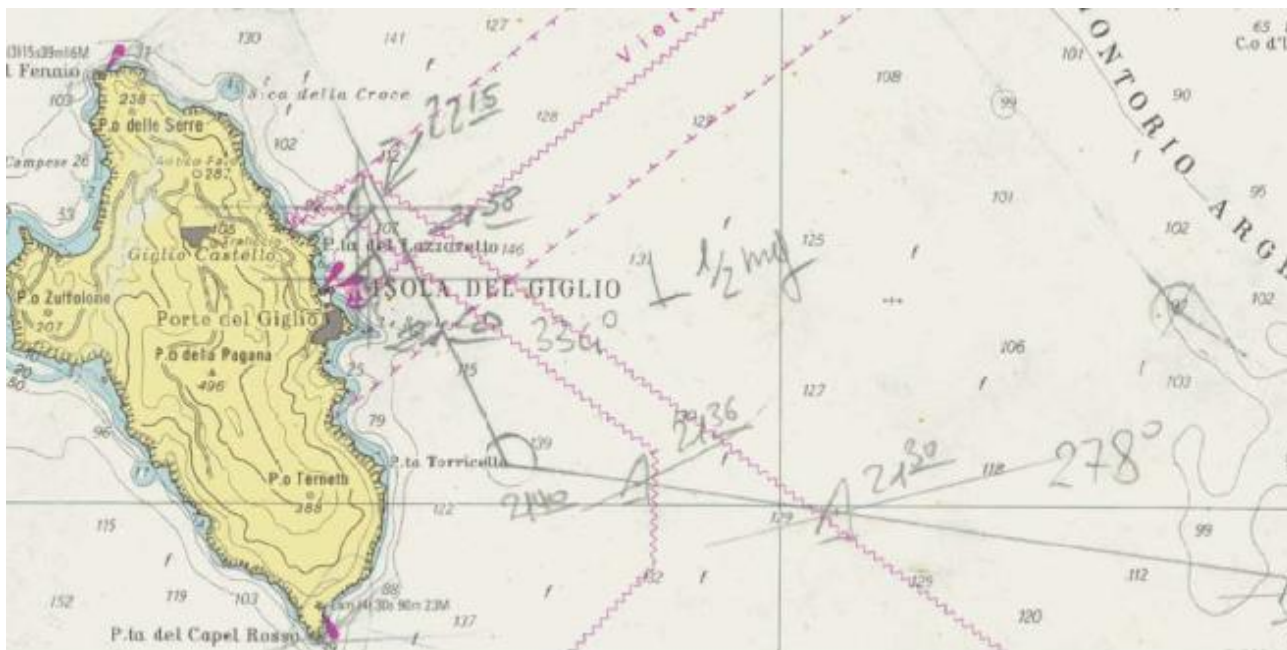
*Excerpt from the chart IIM 6 recovered on board the Costa Concordia*

Planning the voyage of the "Costa Concordia" - January 13, 2012 - was carried out using the chart 6 Hydrographic Institute of the Navy. This paper, scale 1:100 000, is not, as we said, for adequate planning of the route close to the coast which requires more detailed information in consideration of the preliminary assessments for the safety of navigation, taking into account

the parameters and criteria just set forth and contained in the ISM procedure mentioned above.

The extract of the original chart used aboard the ship, and then recovered, shows the planned route and the boat's GPS (indicated by a triangle and time).

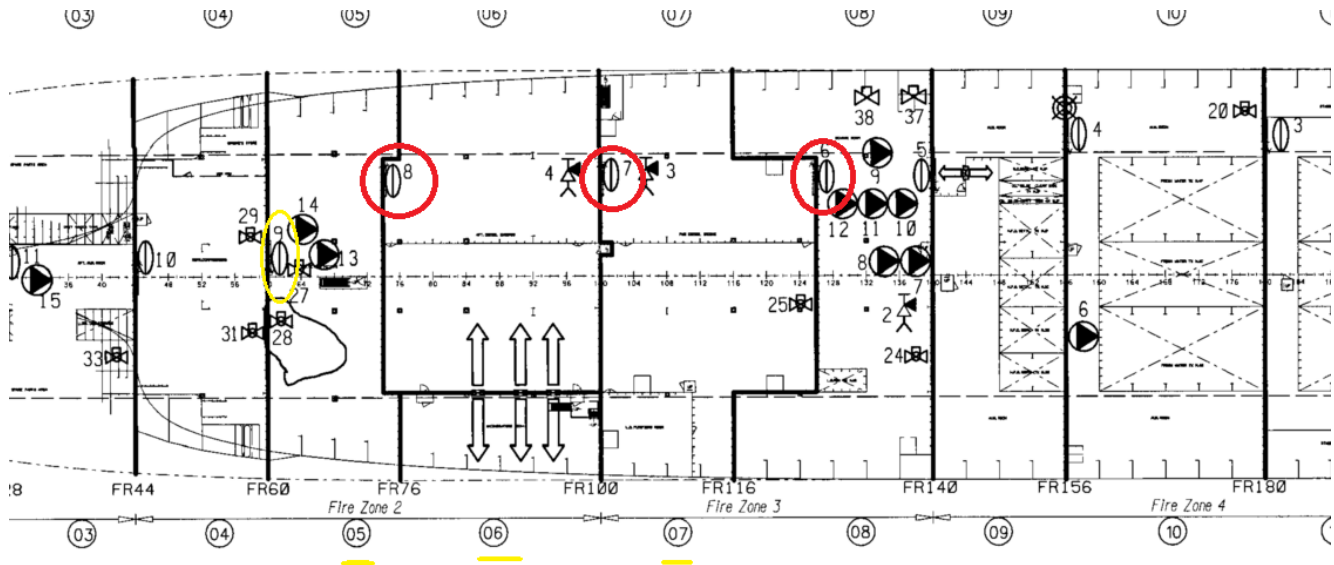
"Damage control plan" - bridge "C"

The compartments immediately affected by the flooding were, among others, 4, 5, 6 and 7 (the number 8 was flooded immediately only into the related double bottom).

From the evidence obtained shows that, at the time of the contact, the watertight doors were all closed, however, and this is confirmed by data from the VDR, as can be seen from the below screen.

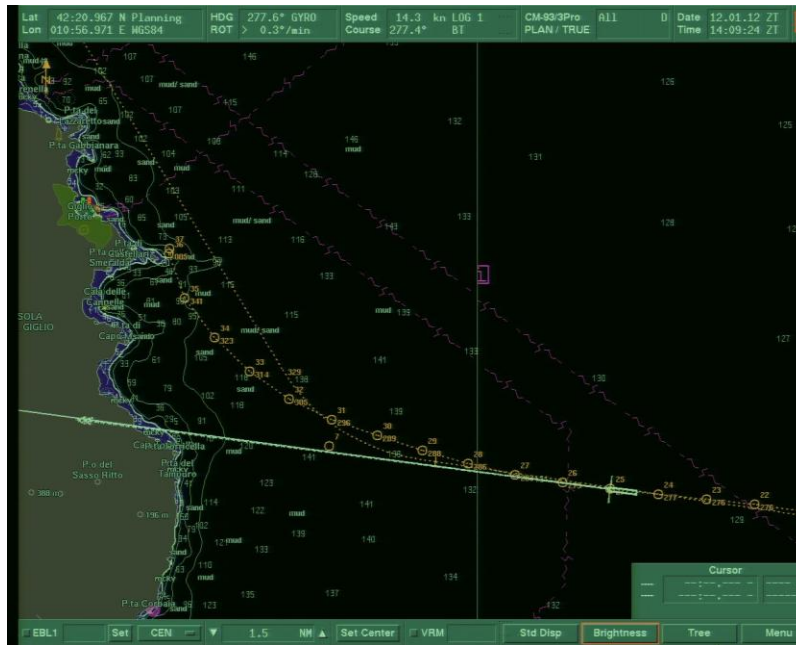
*Overview of the track (extracted by the sailing simulation)*

- A computer simulation has been developed, taking information from various sources, such as witness statements, survey reports and VDR recording data available into account, to obtain a reconstruction of the manoeuvring before the event and the ship's behaviour after the event. This is a reconstruction of the track according to the data extracted by the VDR that was used to make a real simulation of the contact moment that we are going to see in few seconds . It shows the last minutes of navigation before and after the contact against the rocks. Again, to make this simulation, the engaged Company used the official data recovered from the VDR, that's why it is possible to have an actual knowledge of what exactly happened in terms of course/speed/rudder. In particular, the course is reconstructed by simulating manually the track made by the ship during the event and it demonstrates actually how close to the shoreline the course was held and how slow and soft was the related turn. The simulation of the contact was reconstructed by using a reconstruction of the scenario and the track we have just seen, as created into the simulator and the orders given by the Master to the helmsman as recorded and extracted by the VDR. The simulation is done in daytime in order to make visible how close to the shoreline the ship was and that , until the last moments, during the course, the Scole rocks are at starboard, rather than port. However a simulation in night time was made as well (see the video – Appendix no. 4 and statement in Annex no.16).

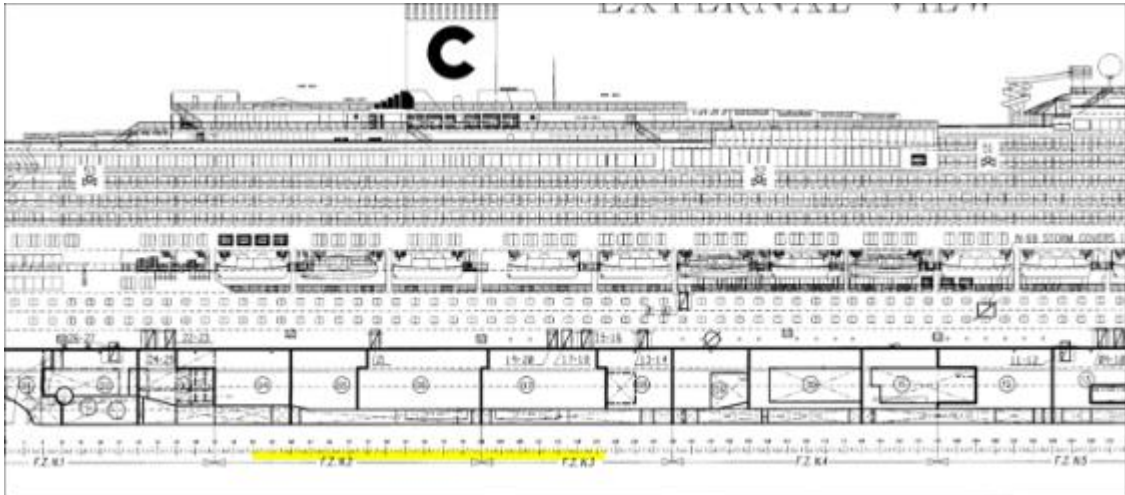
The release of the extraordinary kinetic energy (216,000 Kj<sup>5</sup> - Annex 53) due to the weight of 56,600 tons of the ship - which was sailing at angular speed of over 16 knots [because to the linear advancement of the hull must be added the additional acceleration due to the sudden turn to starboard (ordered at 21 44 20 and completed at 21 44 35, or 22 seconds before impact] - has resulted in an disruptive contact with the rock, which weakened the side and has ripped (torn) due to the simultaneous advancement of the ship. The friction was such strong that the speed, immediately and regardless of subsequent arrest of propulsion was halved at same time.

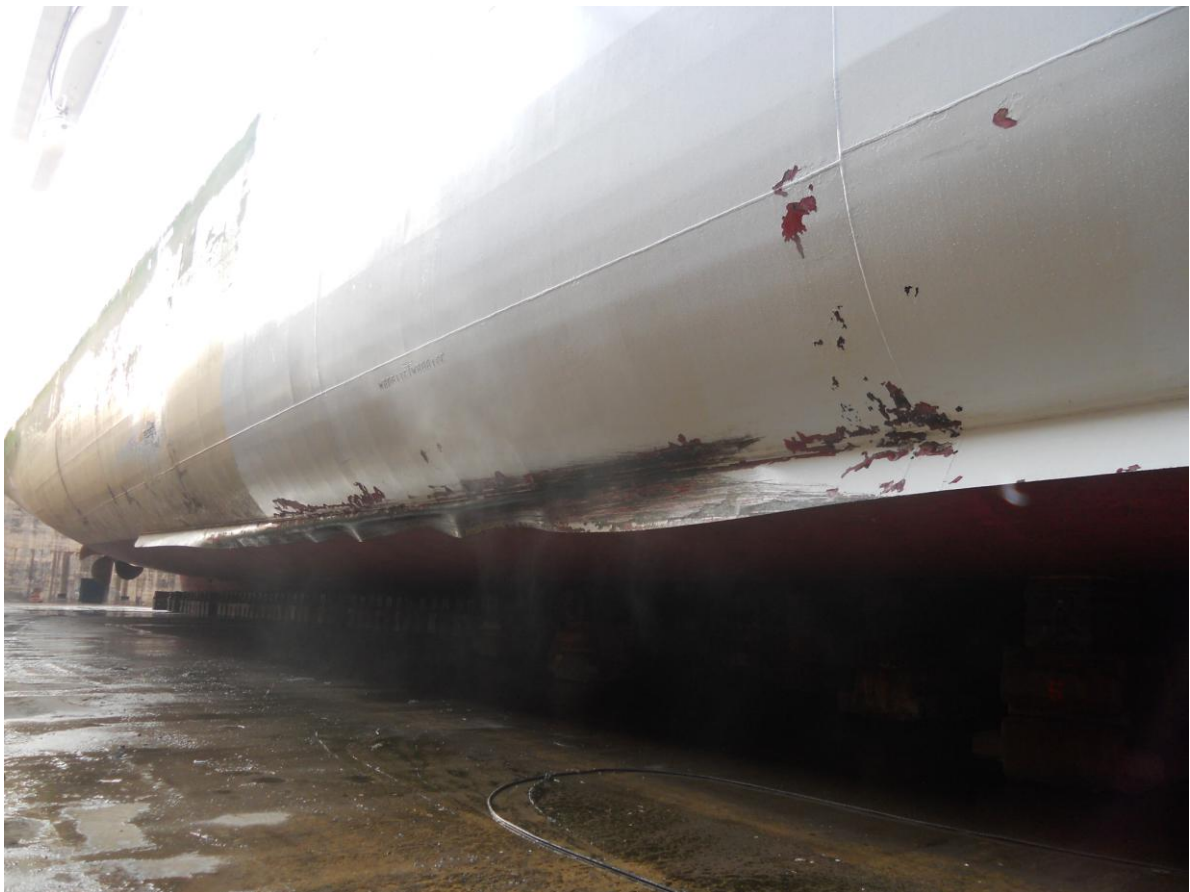
*Following pictures show the hull area interested by the contact (taken from sister ship Costa Serena):*

The hole on the left side upon impact, it is continuous for about 60 meters (about frames 52 to 124) located too far above the deck of the Double Bottom (so well over two meters from keel line). This was crucial in terms of severity of the accident, because rather than be hit the bottom of the ship, if the more defence due to the double hull, was vice versa affected area clear that, over the plate rail, relies directly its operating compartments (the heart). In particular, the testimonies of the 3rd Engineer Officer and 2nd Engineer Officer, as well as the 2nd Chief Engineer) - combined with audio recordings of communications between the VDR machine and Bridge - have established that in a few minutes (about 3 mins for the EMP and 7 for Diesel Generators Room. aft) the ship has lost Watertight Compartments (WC) nr. 5 and 6 (PEM and then Local DD.GG. aft), while the adjacent WC nr. 4 and 7 (respectively Compressors Galley Room and DG Room), were initially partially flooded, becoming initially dangerous free liquid water surfaces, and then completely filled after about 40 minutes from the contact.

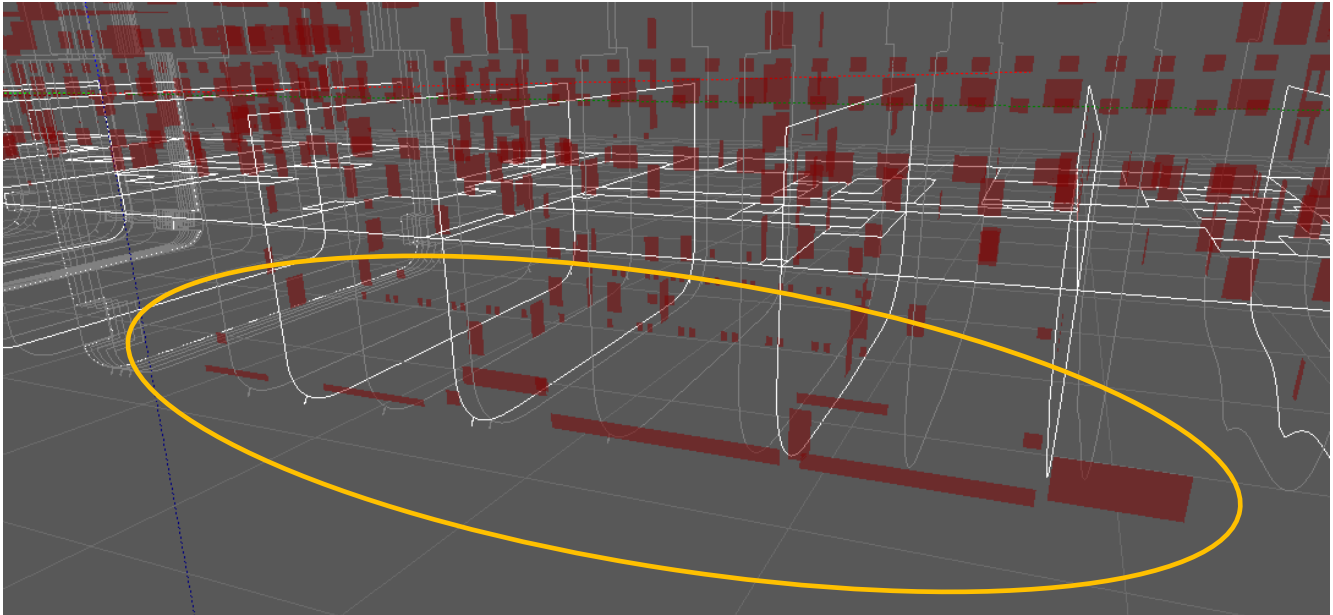
*Assumed damaged extent (according with flooding simulation)*

An assumed density of 2.7 tonnes/m<sup>3</sup> has been used to estimate the buoyancy of the rock to allow the submerged weight of the rock to be applied in the moment calculation. It has been estimated that the transverse centre of gravity of the rock is at 10.7m from the centre line of the vessel. The calculated moment is applied in the simulation at time 213 seconds which is at the end of the first grounding event.

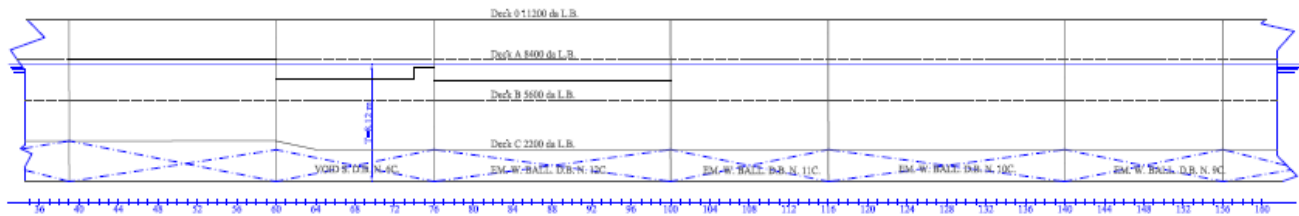
Compartimentazione nave nel piano longitudinale a murata

In order to immediately appreciate the position and magnitude of the breaches occurred as a consequence of the impact, please refer to the following drawings:

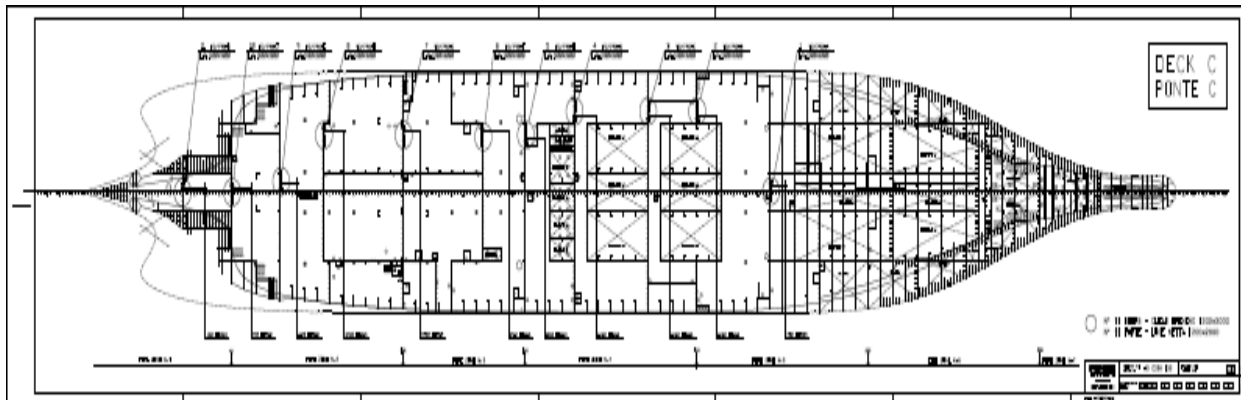
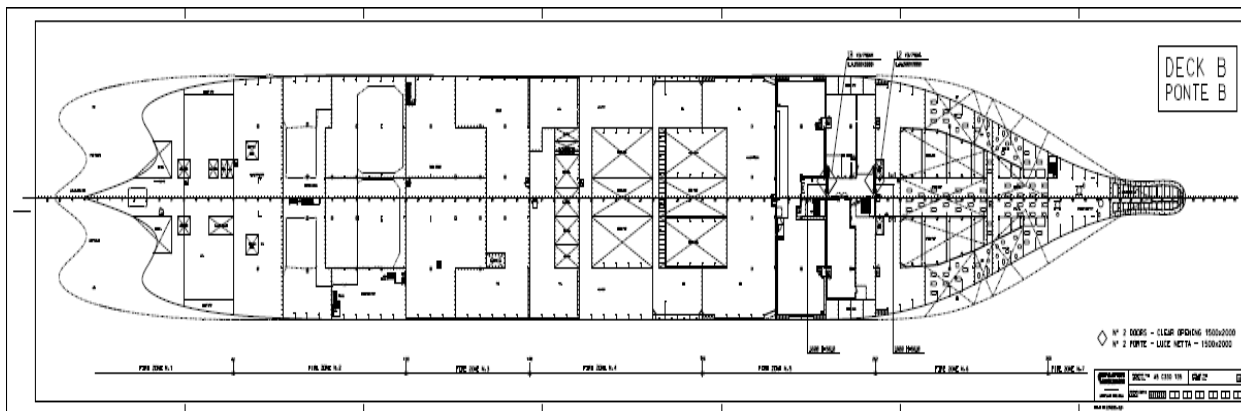
The watertight doors are located in the subdivision of the following compartments represented below:

A useful information concerning stability is the state of watertight doors within the range of time before and during the contact. These data are extracted by the VDR and they confirm that at 21.45, at the time of the contact, the watertight doors were all closed. This gives confirmation to the declaration delivered by the Third Engineering in duty at the time of the accident in the area interested by the breach.

In particular watertight doors 6,7,8,9,10 connecting the flooded compartments. The only exception are watertight doors 12 and 13, in the laundry department, which connected watertight compartments not involved by the flooding in any case.

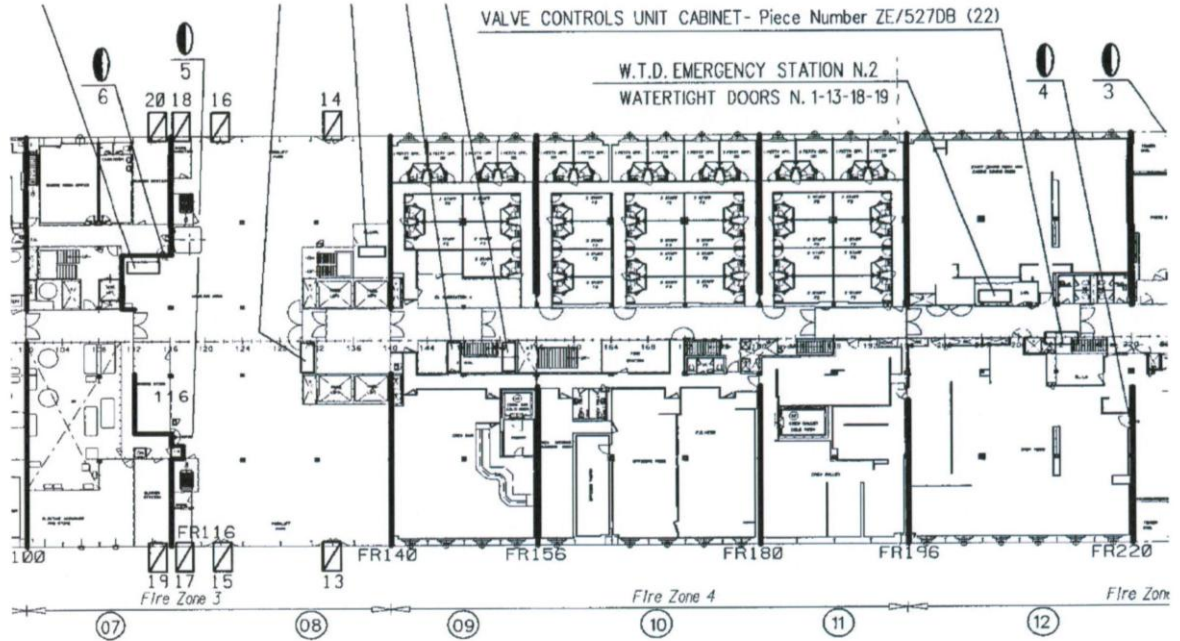
Figure B

Splashtight Door plan Deck 0 mid

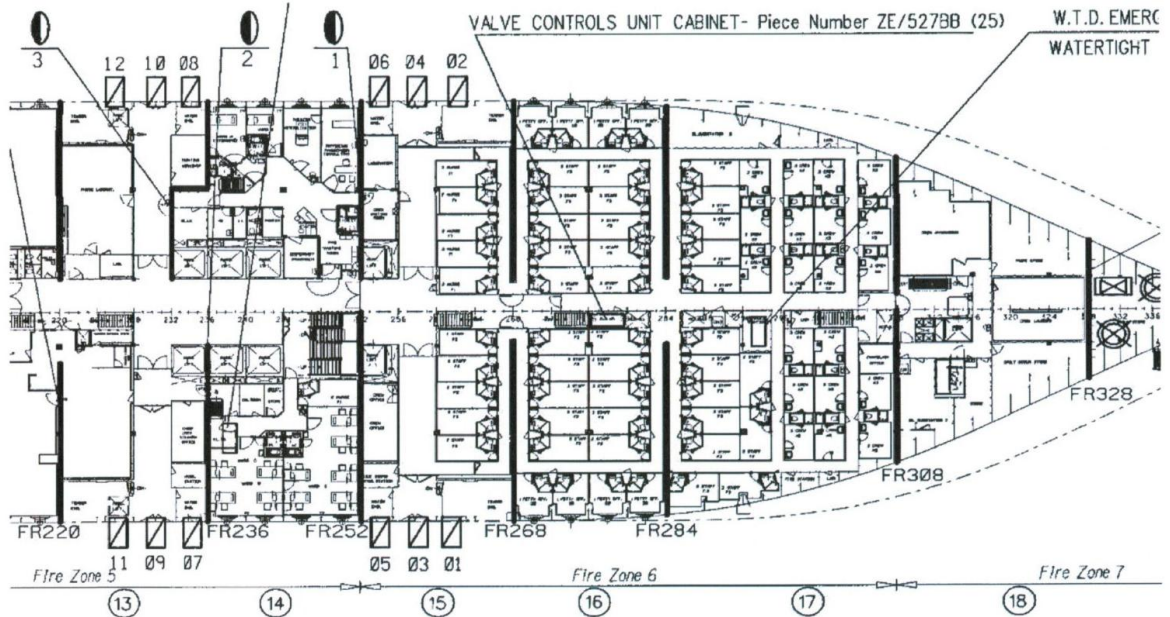
Figure C

Splashtight Door plan Deck 0 fwd

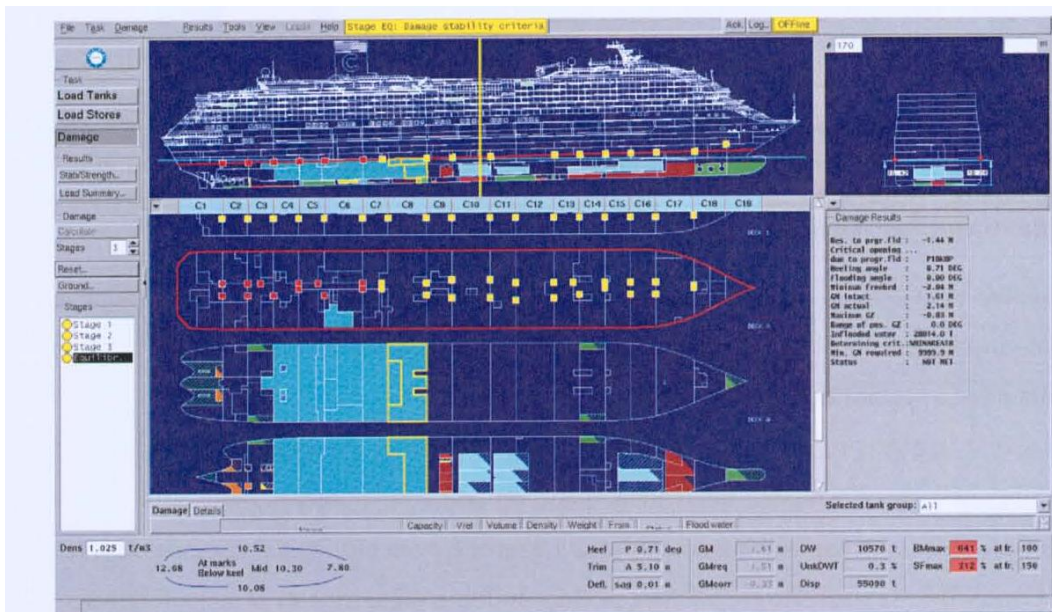
Figura 34

On the area of the bulkhead deck not yet submerged there are anyway other 22 potential water ingresses (yellow dots).

Thus the progress of flooding through these accesses would have led to the ship's sinking.

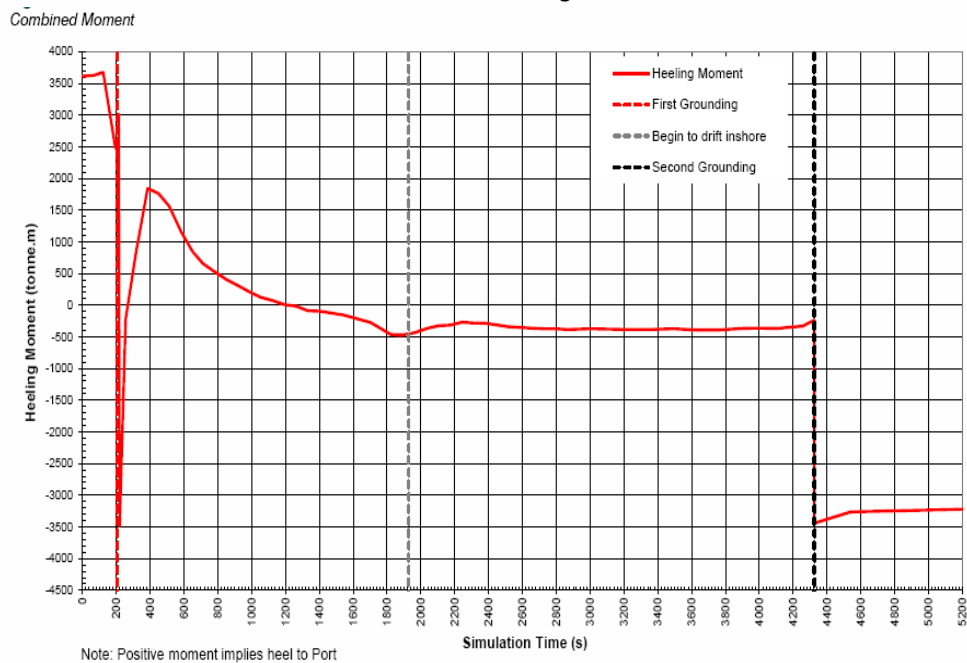
The drifting applicable moments are due to the wind (NE 18 knots), turning, final grounding and the weight of the rock got stuck into the hull (97t). The combined moment diagram after the impact with the Scale is the one here below – Figure n. D:

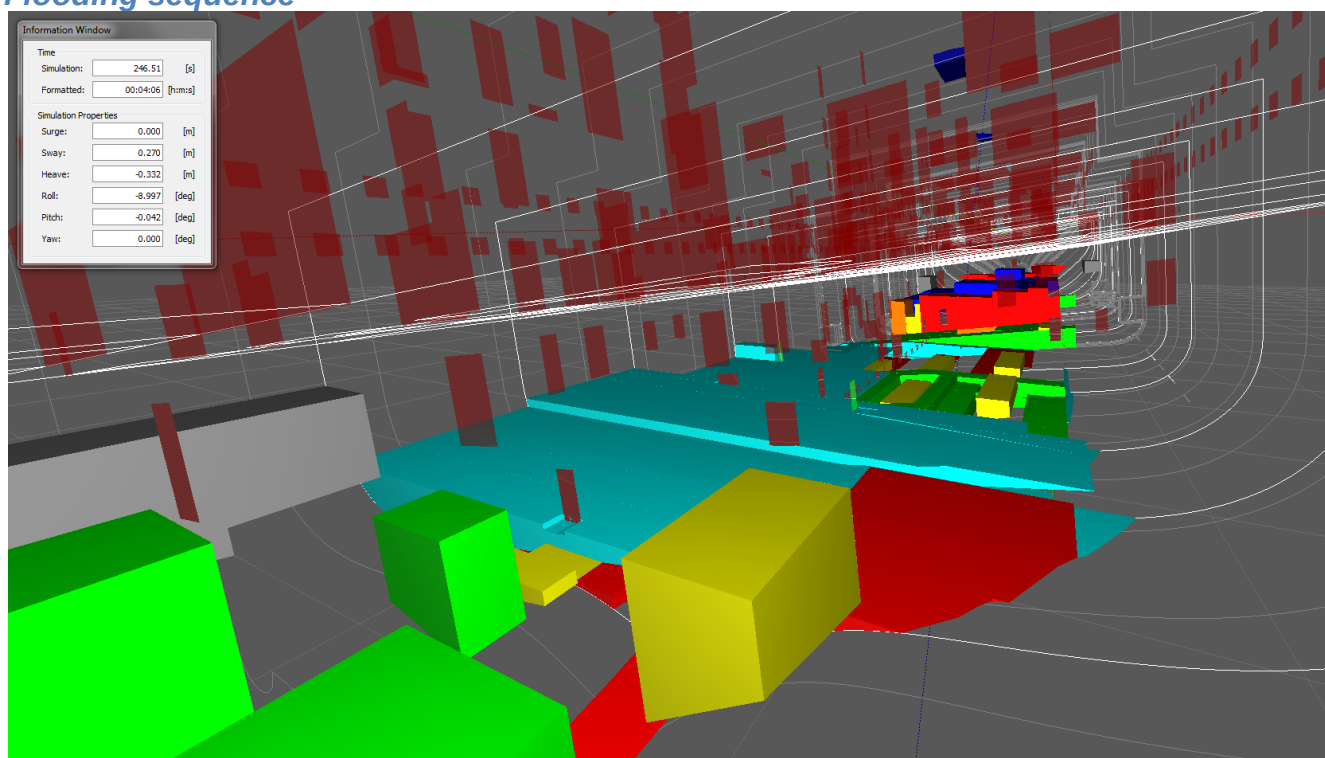
### Flooding sequence

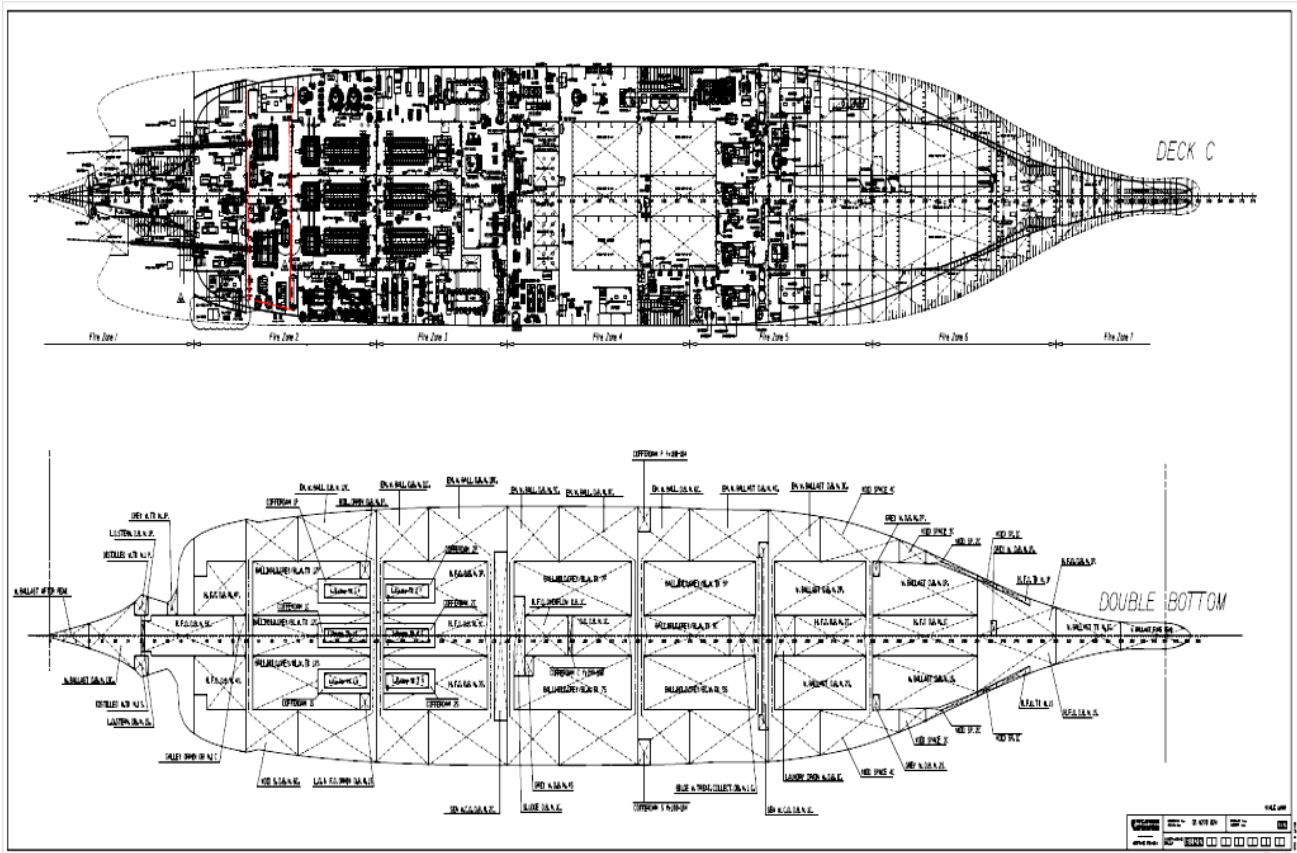
The compartments involved by flooding contain the machinery that in Enclosure no 3 attached to Appendix no 9 and reproduced in the following arrangements:
